SAN JACINTO RIVER WASTE PITS TIME CRITICAL REMOVAL ACTION REPORT ON REASSESSMENT OF DESIGN AND CONSTRUCTION

April 2013

During a regularly scheduled inspection of the TCRA cap on July 20, 2012, visible geotextile was observed in localized small areas of the outer face of the western berm. In accordance with the OMM Plan, USEPA was notified and a maintenance plan was prepared, approved by the USEPA, and implemented by Respondents' contractor. A TCRA Maintenance Completion Report was then prepared and submitted to USEPA on August 27, 2012. On July 31, 2012, USEPA sent a letter to the Respondents requesting that the design and construction of the TCRA be re-assessed in light of the need for maintenance. This report presents the Respondents' reassessment of the TCRA design and construction, and specifically evaluates conditions related to the July 2012 maintenance event to identify the primary cause that triggered the need for maintenance.

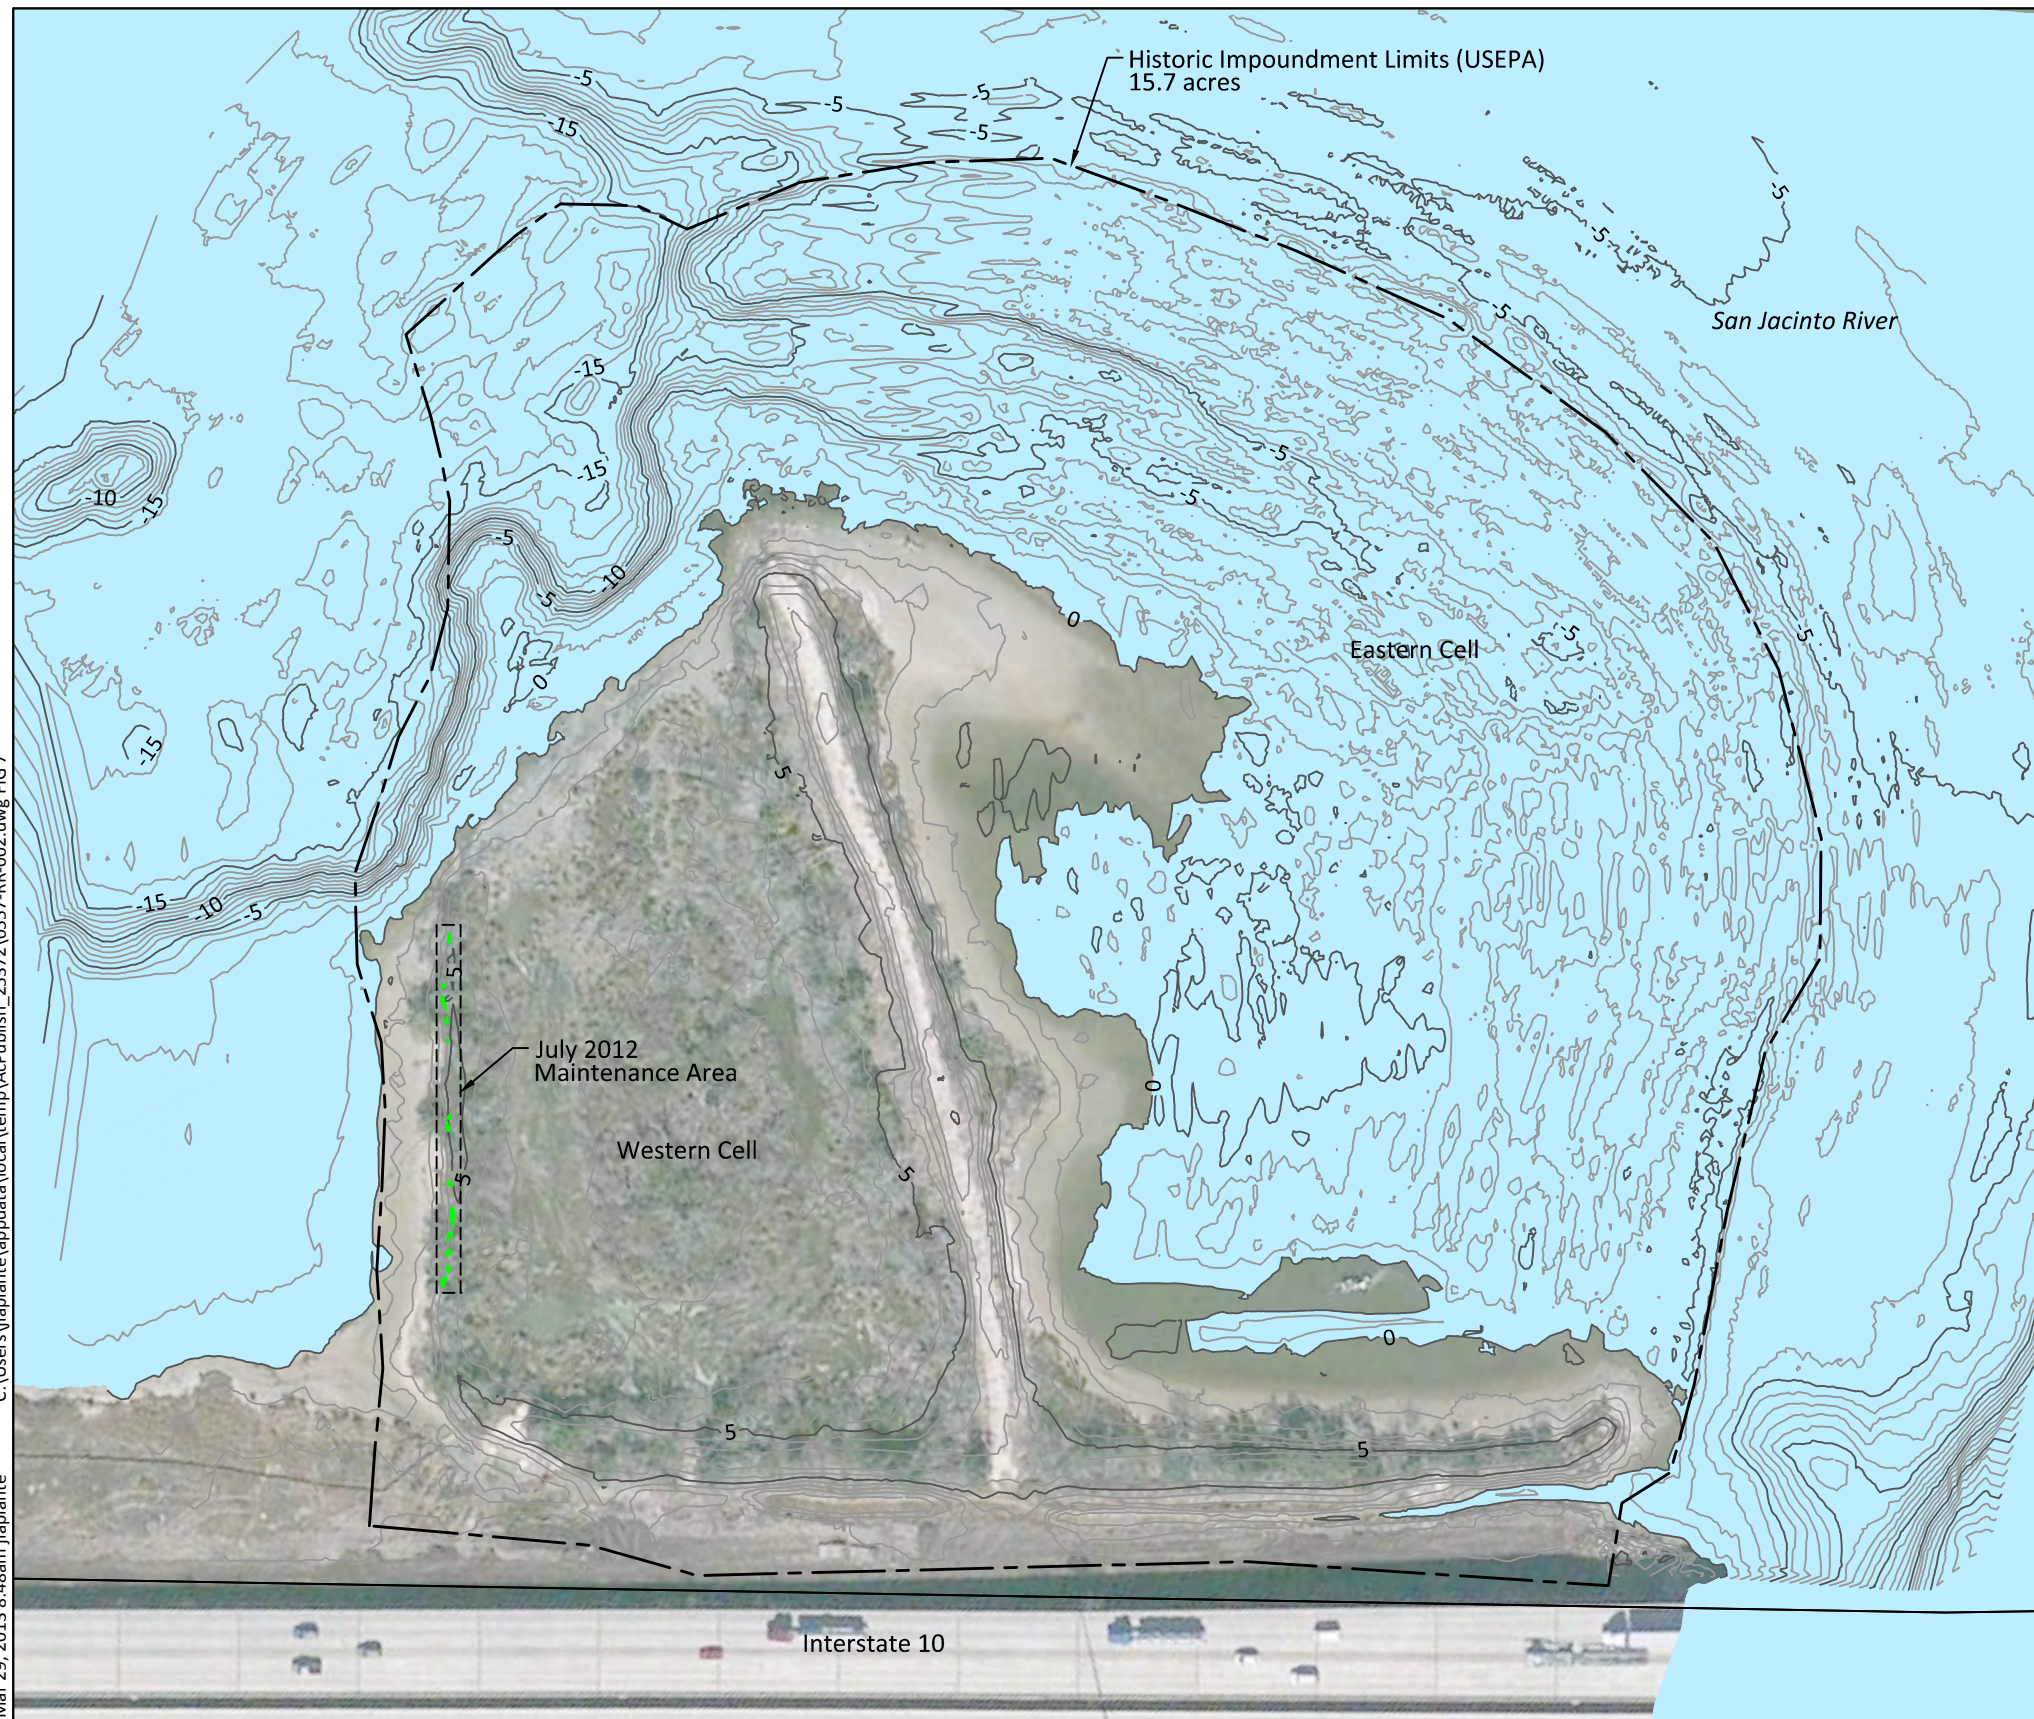
Mar 29, 2013 8:48am jiplante C:\Users\jiplante\appdata\local\Temp\AcPublish_25372\0557-RP-002.dwg FIG 7

During a regularly scheduled TCRA cap inspection in July 2012, geotextile was found to be visible in isolated small areas on the outside face of the western berm. Detailed mapping of these areas (Figure 7) showed that the visible geotextile was correlated with areas of the western berm face wherein the subgrade appeared to be steeper than the design 2H:1V. These areas were limited to short vertical heights (generally within 1 to 2 vertical feet). The overall slope of the western berm face, as measured from the toe of the berm to the crest of the berm was 2H:1V or flatter.

- — — — — Post-Construction Contour, 8/19/11 to 9/2/11 (1-foot interval)
- - - - - Historic Impoundment Limit (USEPA)
- Approximate Limits of Maintenance Activity
- Surveyed Area of Steeper Slopes

In the maintenance areas of the western berm, it was noted that the underlying berm cap subgrade (covered by geotextile) was as steep as 1 horizontal to 1 vertical (1H:1V) over short distances (approximately 1 to 2 feet high) and in limited areas. Prior to construction of the TCRA cap, the steepest slopes at the impoundments north of I-10 were observed to be approximately 2H:1V, and the stability of 2H:1V slopes was evaluated in the TCRA RAWP (Anchor QEA 2010) and determined to be acceptable.

The primary factor triggering the need for maintenance on the western berm was the presence of localized, steeper cap subgrade conditions. These conditions are presumed to have occurred during the clearing and grubbing activities. Contributing factors are associated with the July 2012 storm event, which resulted in wind-generated wave attack along the face of the western berm. These wind-generated waves had the potential to move the finer-grained fraction of the armor rock, which could have triggered down-slope movement of the larger fraction of the Armor Cap B/C aggregate in those limited areas of the western berm that were steeper than 2H:1V.

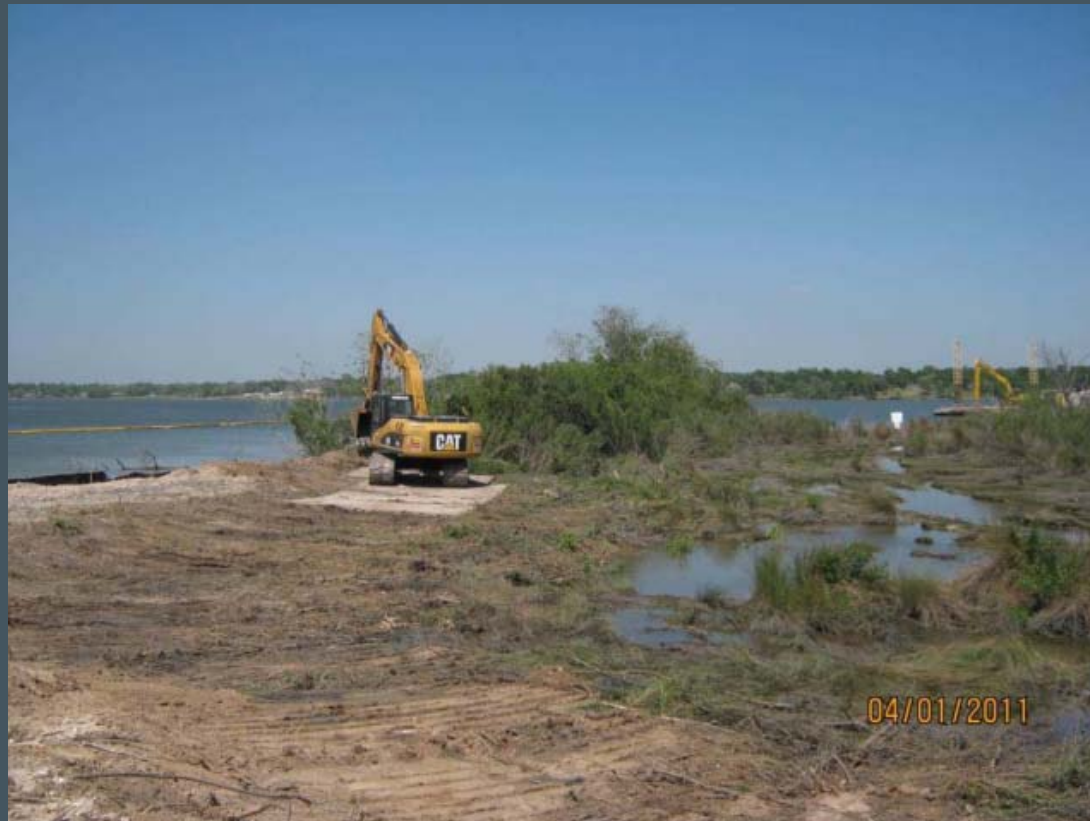
Smoothing the ground surface in the Western Cell in preparation for geotextile deployment. (Daily Report – April 1, 2011 No. 72)

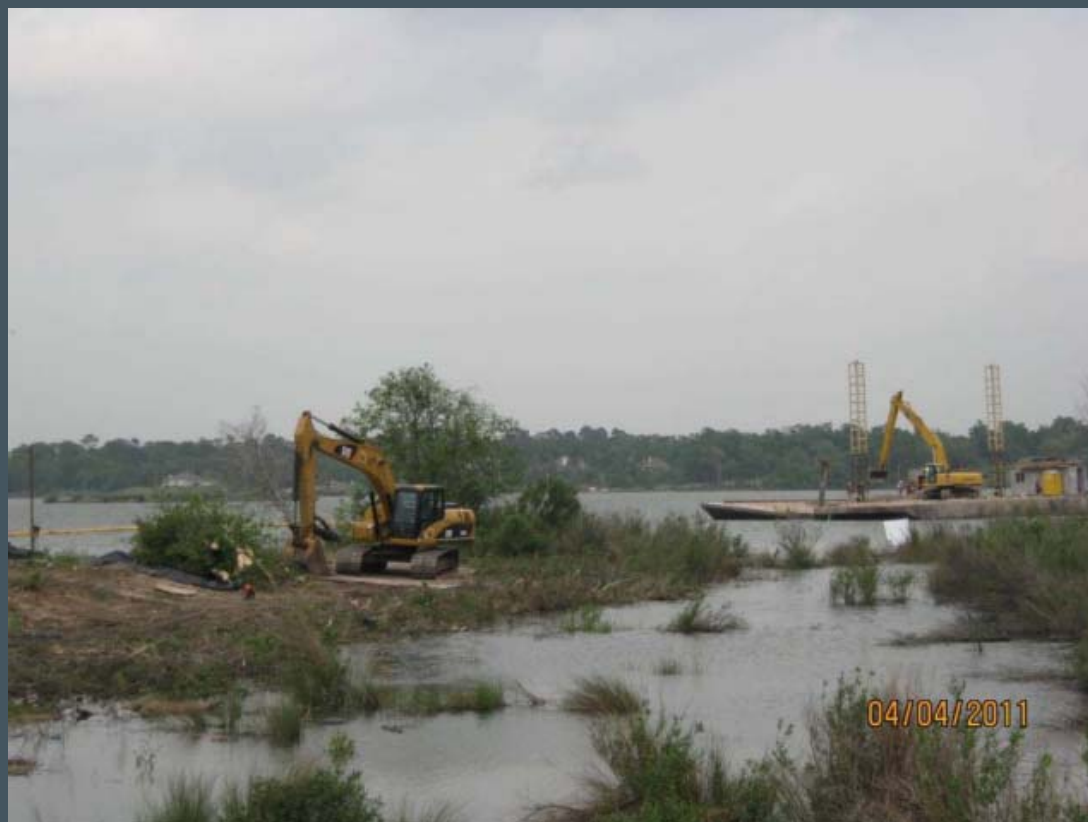
Clearing vegetation along the western berm of the Western Cell in preparation for geotextile deployment. (Daily Report – April 4, 2011 No. 73)

root wads would have resulted in pockets of material being moved around, which could have caused localized steeper areas in these pockets.

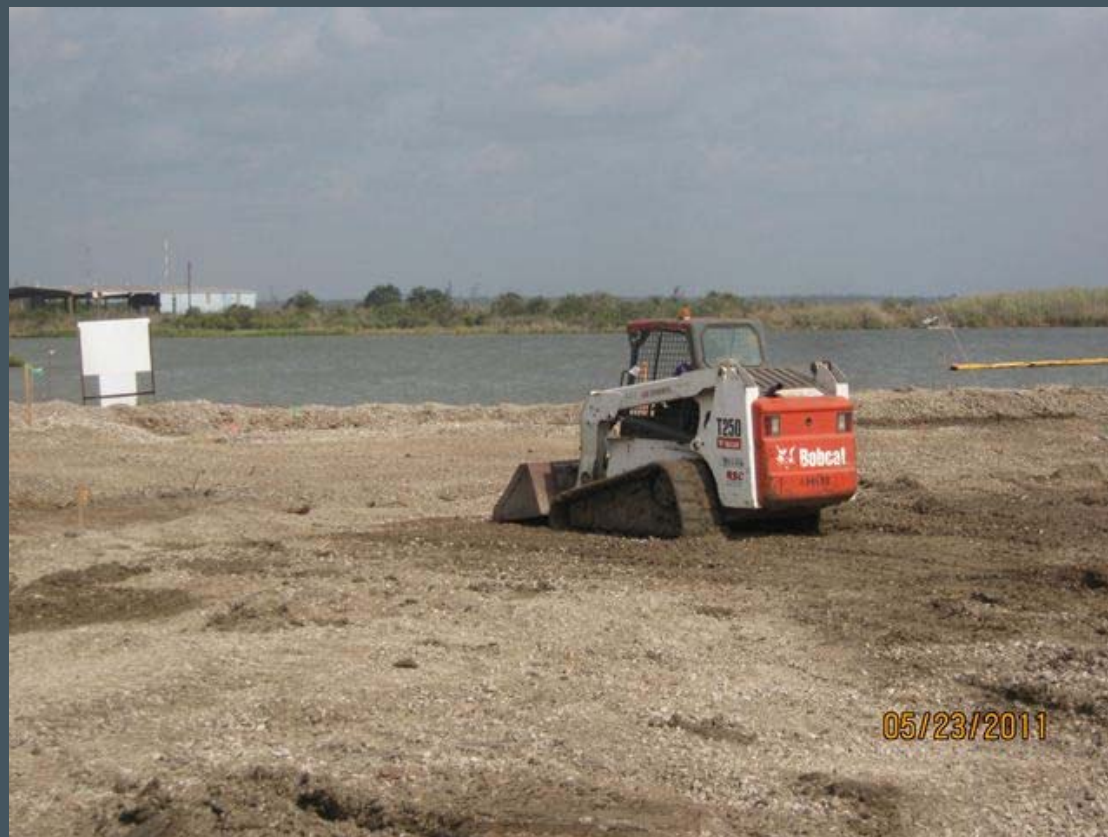
Skid steer grading CCRB across the surface of the Western Cell.
(Photograph: 2011-05-23.02)

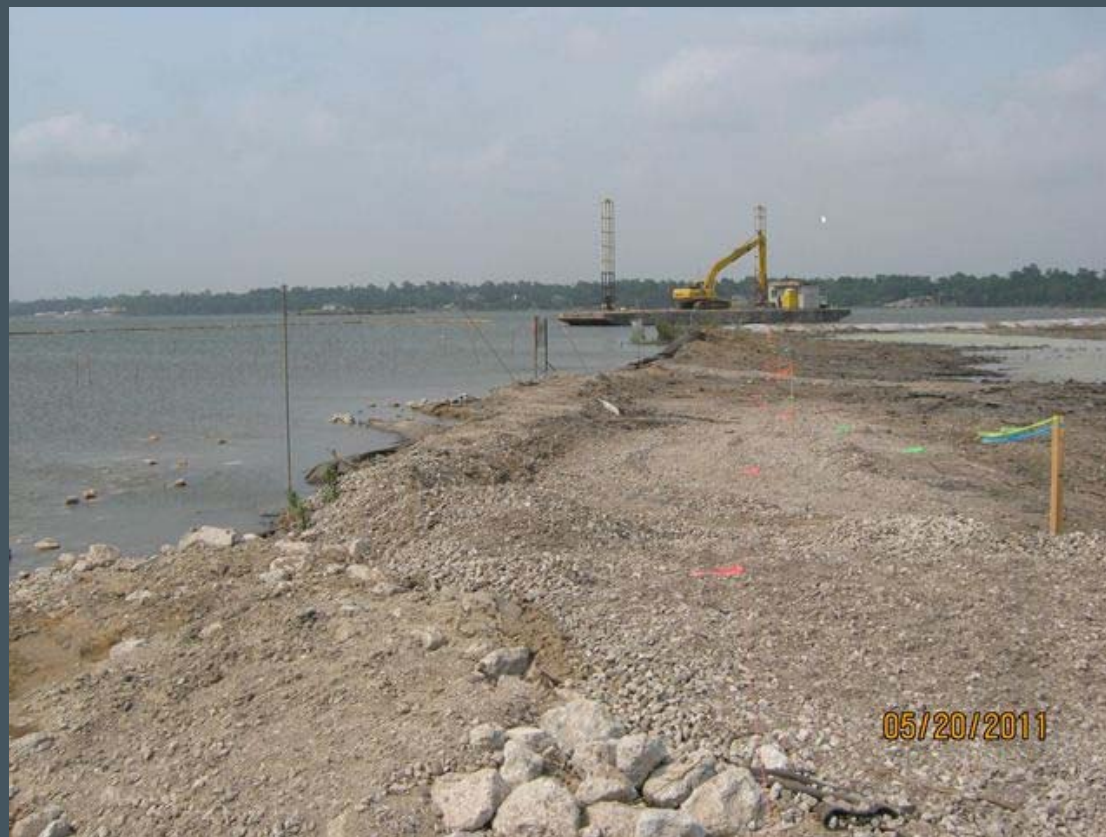
Western berm of the Western Cell. (Photograph: 2011-05-20.11)

This root cause assessment is supported by a review of photographs (Appendix A) taken during the capping of the western cell. In one photograph, portions of the outer face of the western berm subgrade that are covered in geotextile (but prior to armor rock placement) appear to be steeper than the design 2H:1V slope.

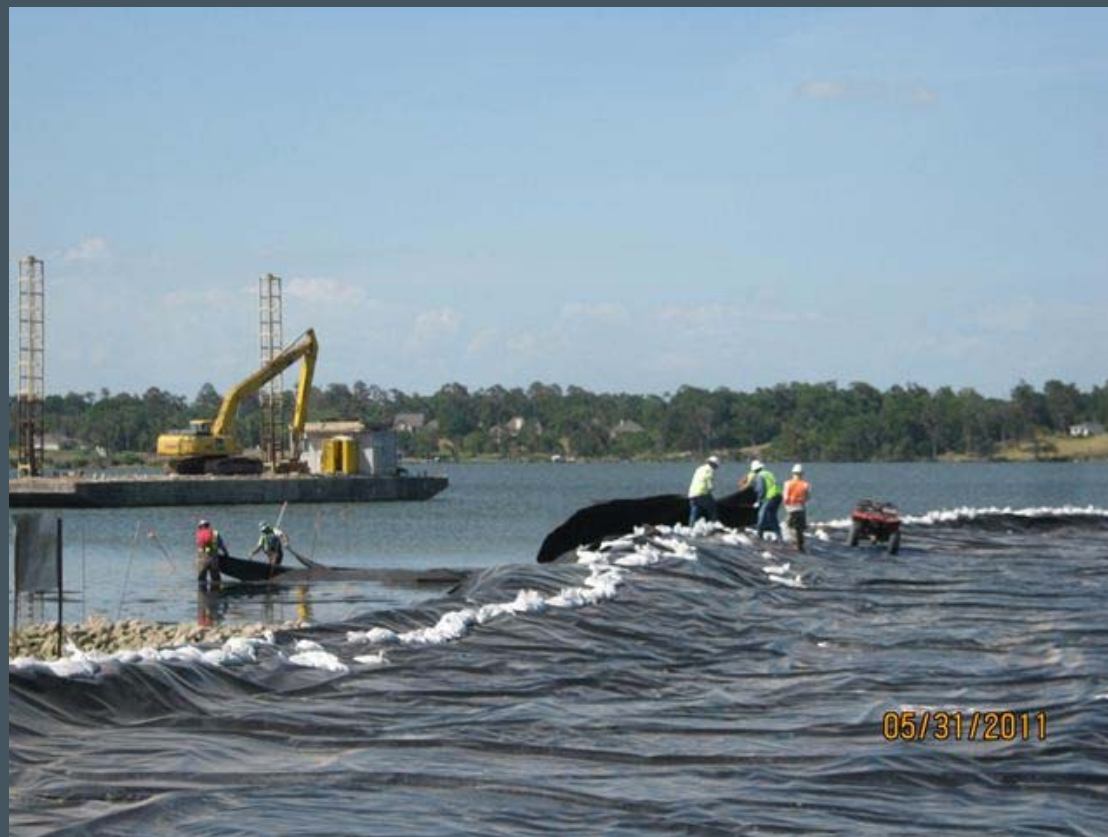
Deploying geotextile outside the western berm of the Western Cell.
(Photograph: 2011-05-31.13)

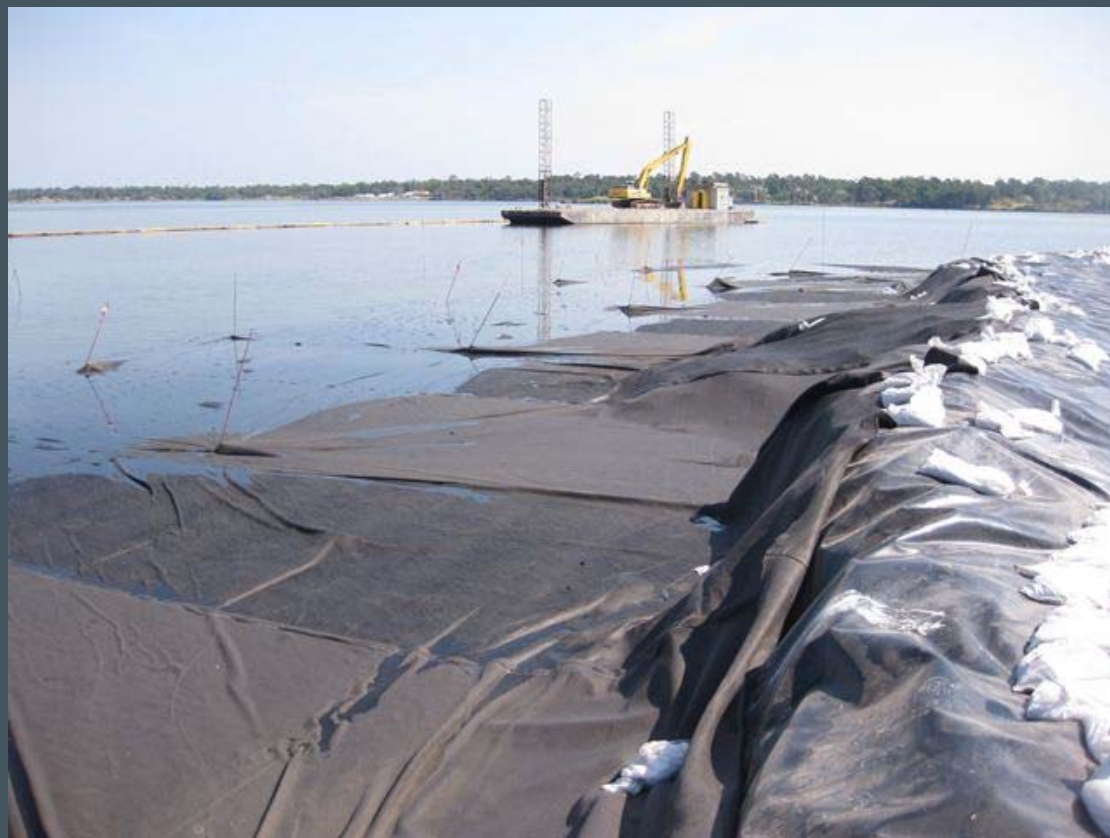
Geotextile deployed along the western berm and to the west of the Western Cell.
(Photograph: 2011-06-01.02)

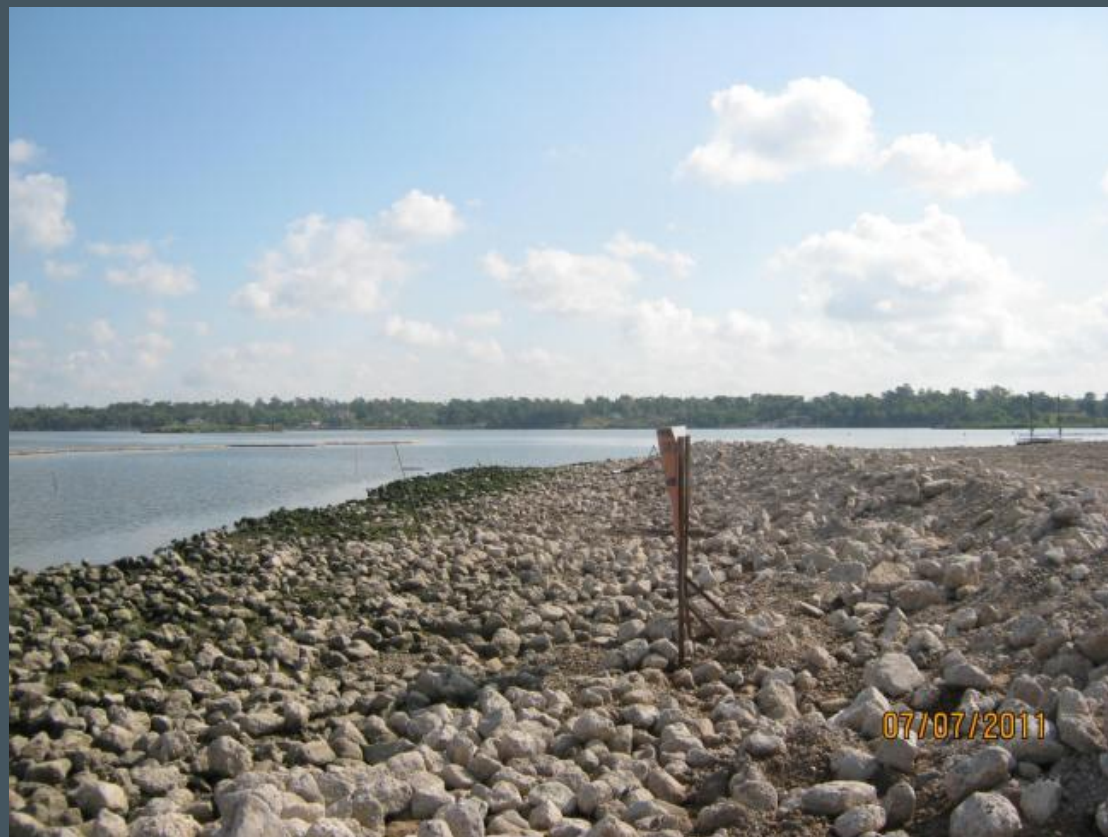
Western berm following construction. (Photograph: 2011-07-07.01)

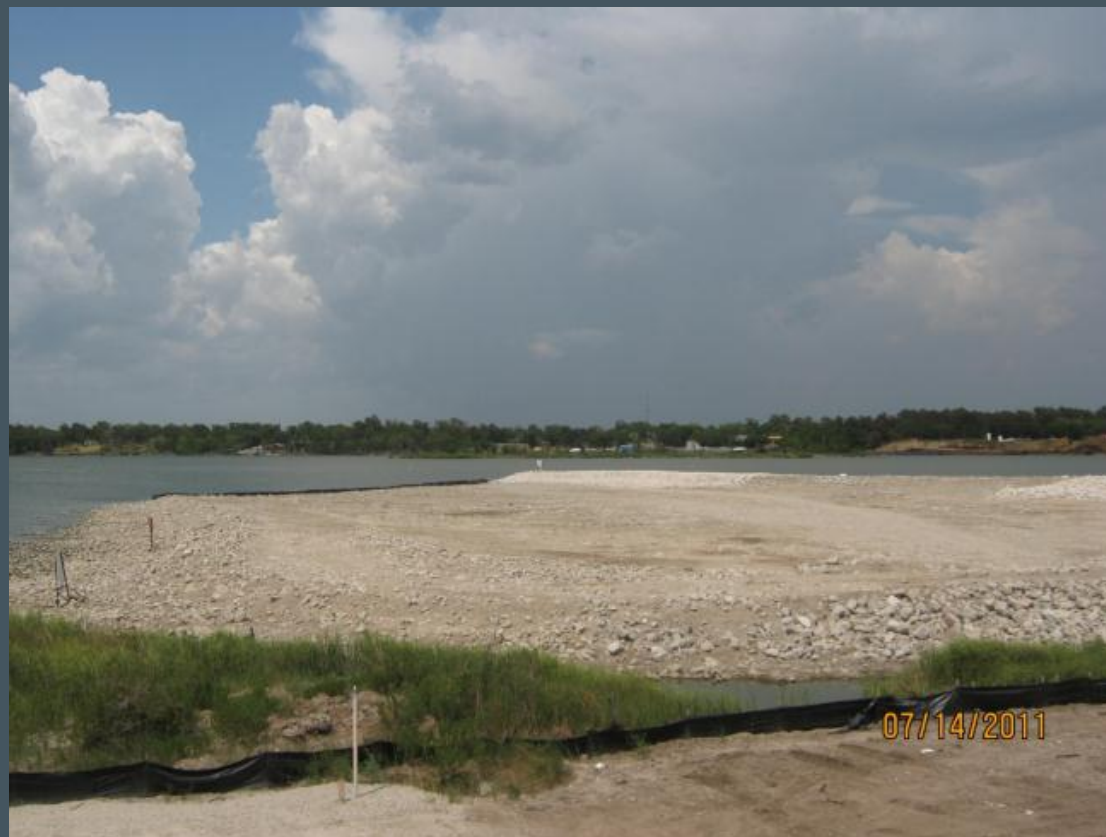
Western Cell following construction completion. (Photograph: 2011-07-14.14)

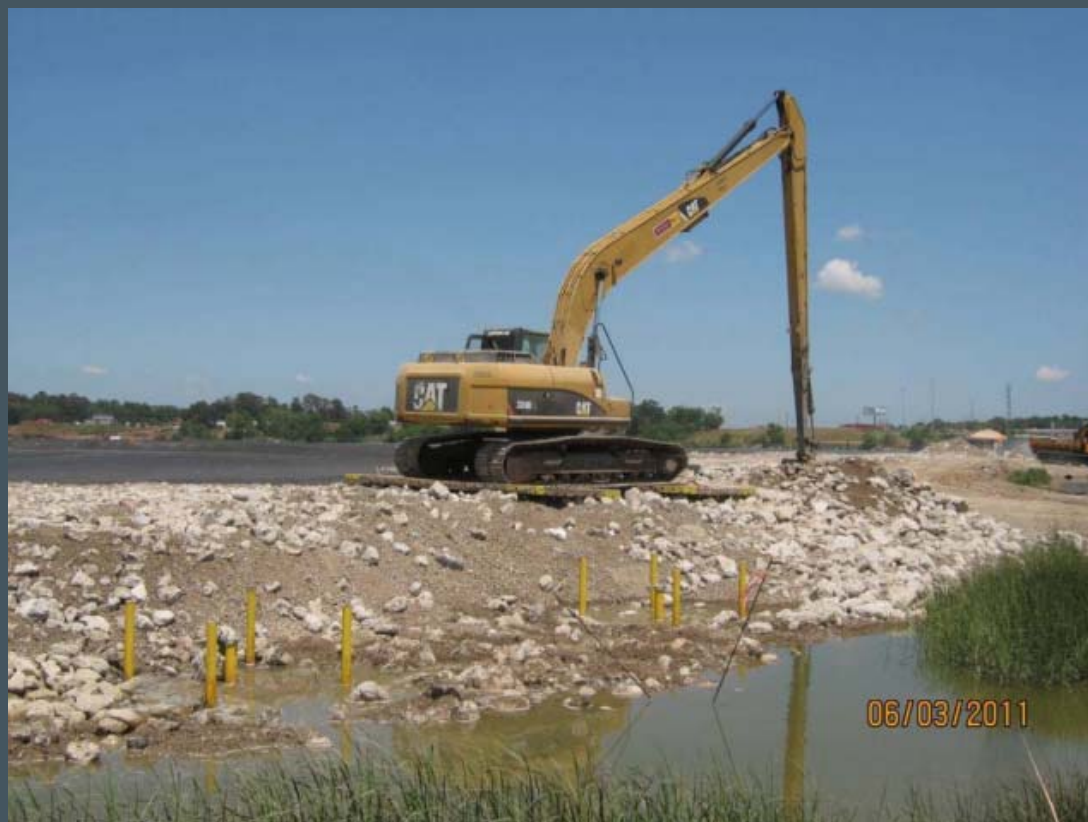
- Photograph taken on June 3, 2011 shows the long-reach excavator near the southwest corner, where the long-reach excavator could position itself directly on the southern berm.
- On June 7, 2011, the long-reach excavator was located on the interior side of the Western Cell in order to place the armor rock on the western edge of the cap.

Placing B/C armor rock outside the southwest corner of the Western Cell.
(Daily Report – June 3, 2011 No. 119)

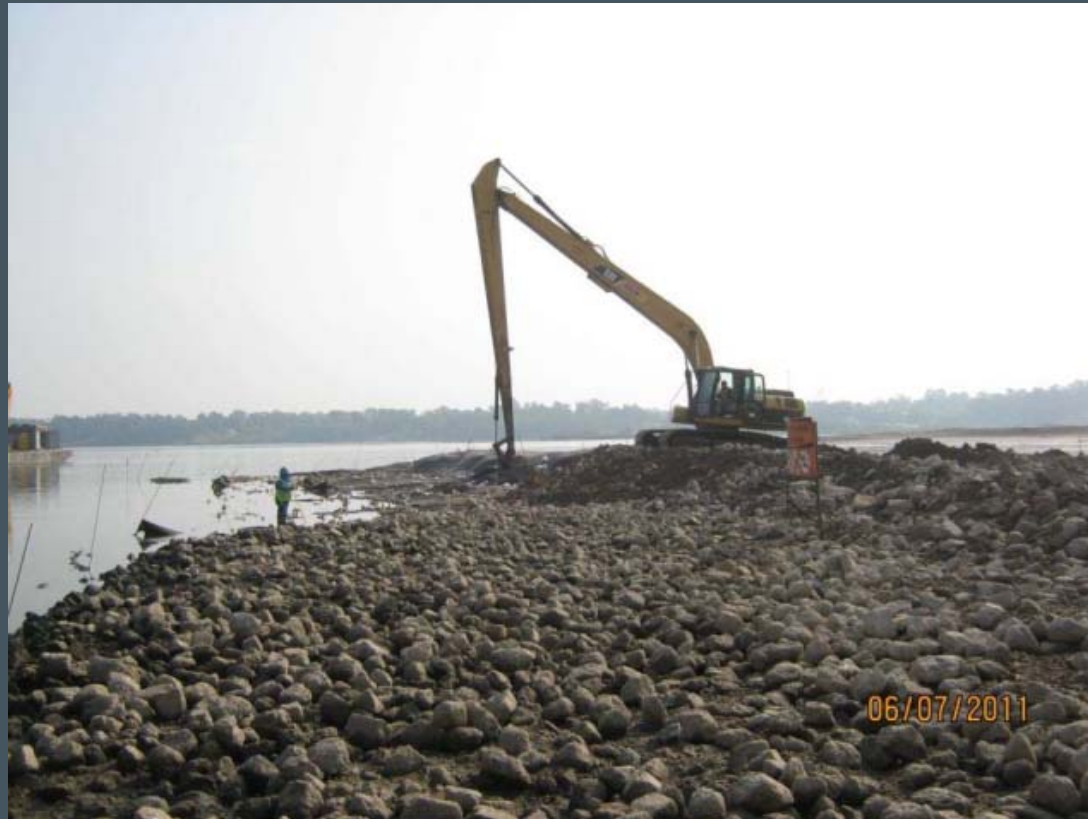
Placing B/C armor rock across the western berm in the Western Cell.
(Daily Report – June 7, 2011 No. 122)

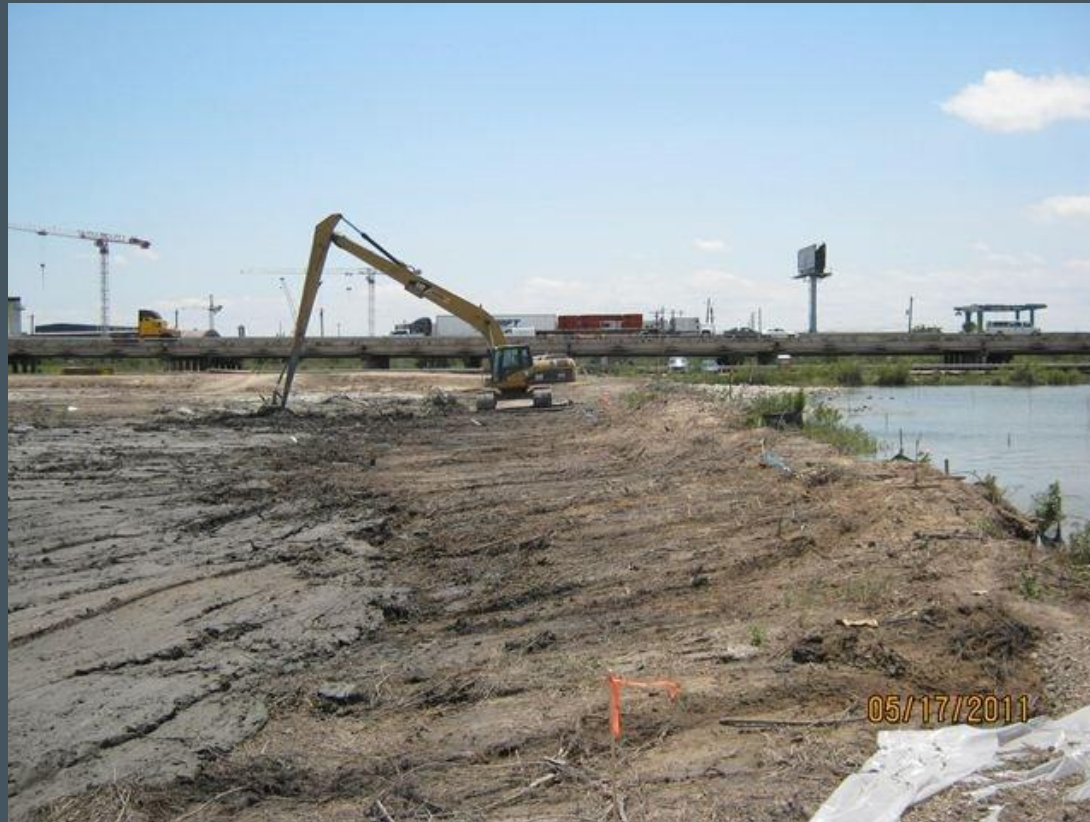
Western Cell stabilization adjacent to the western berm.
(Photograph: 2011-05-17.10)

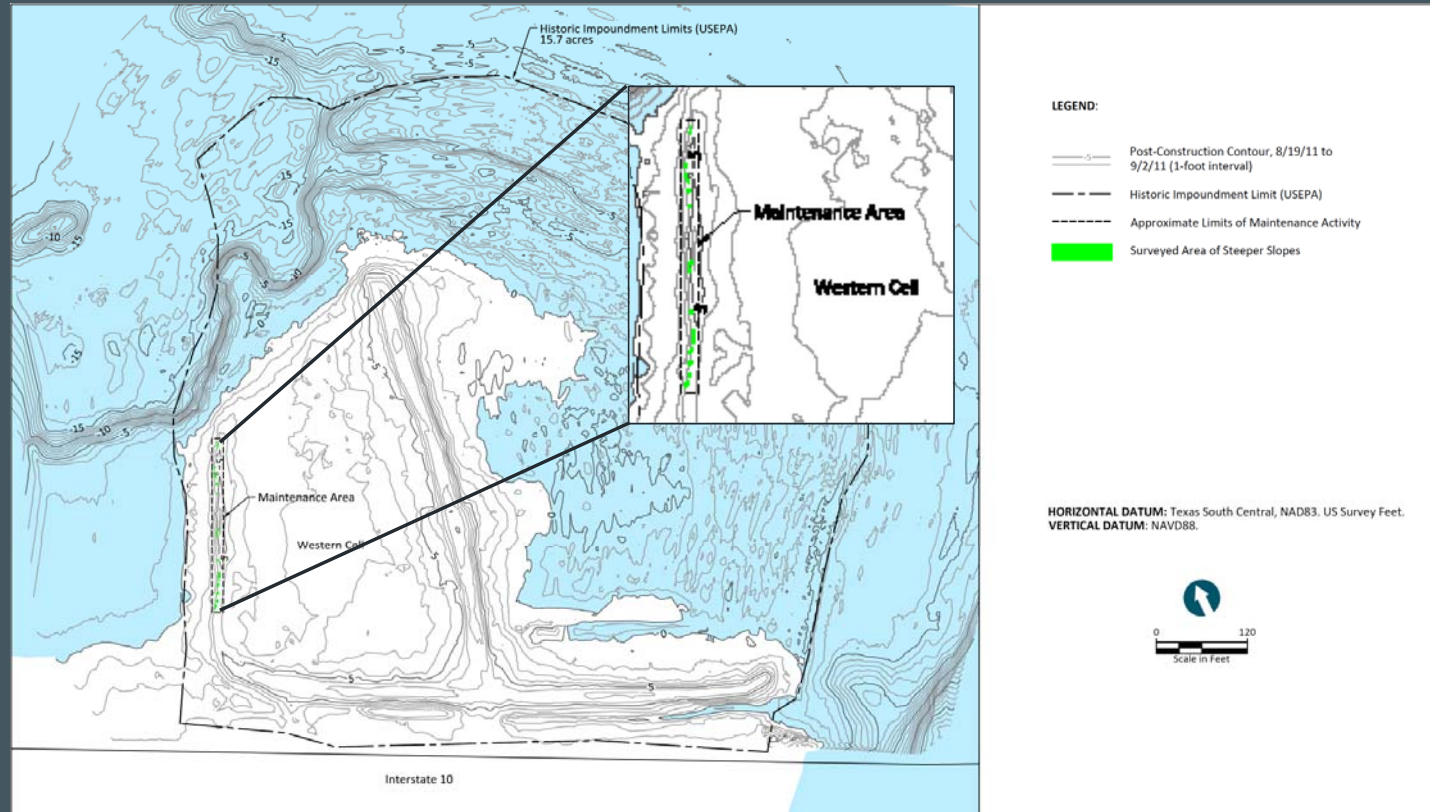
The survey data and visual inspection showed the design slopes of 2H:1V were achieved. Areas were identified during the repair activity planning for the western berm using detailed topographic survey techniques and showed small scale slopes that were steeper than 2H:1V along the western berm. The total area with those steep slopes was about 80 square feet and is shown on the following slide.

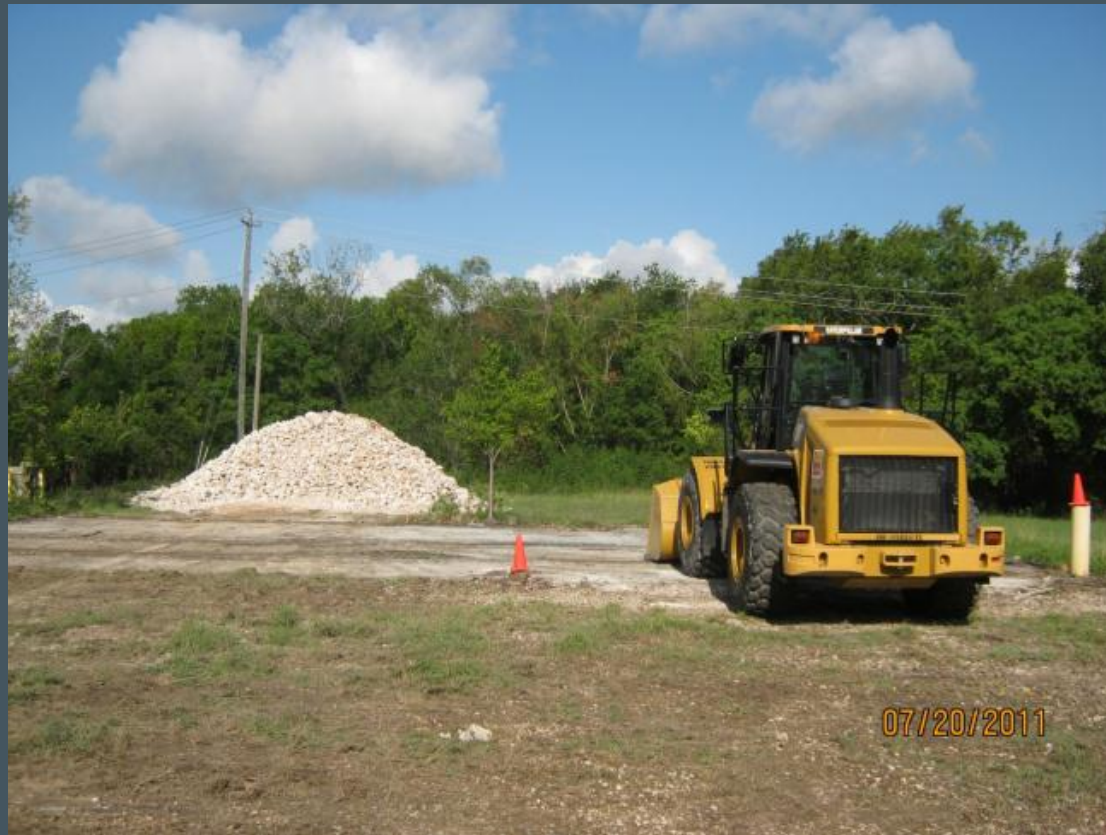
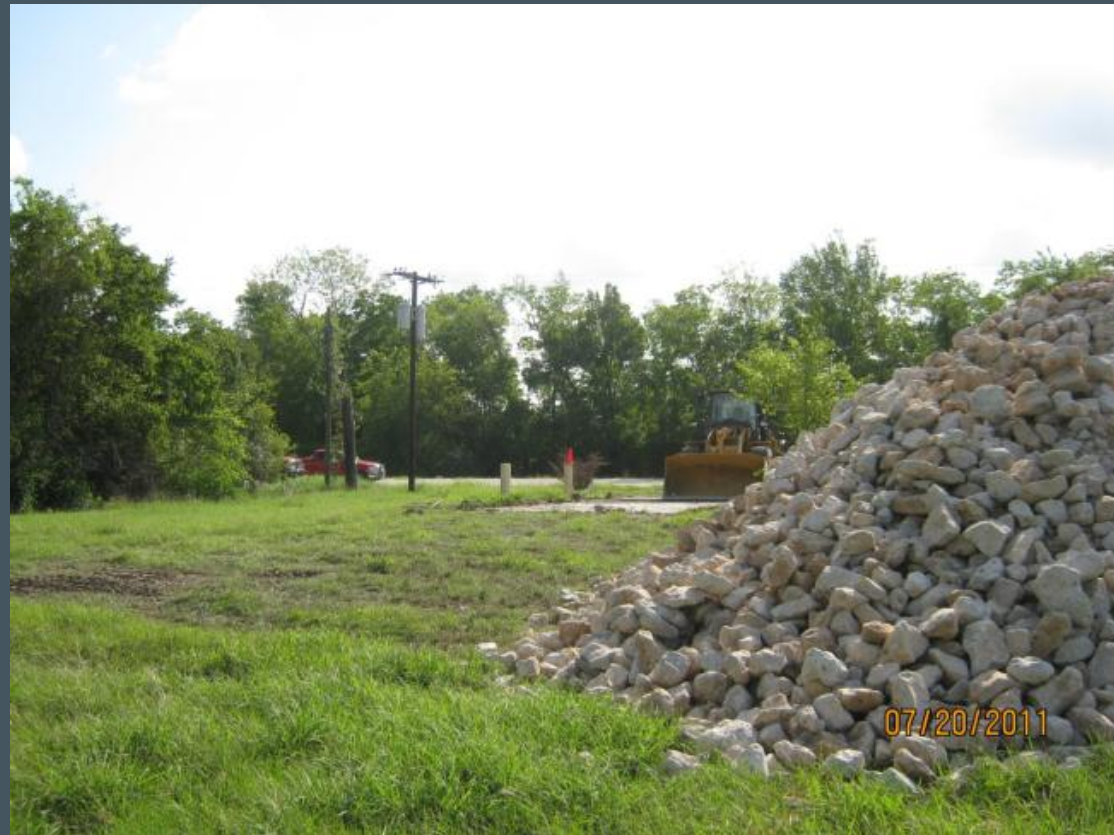
Stockpiling C armor rock at the off-site stockpile area.
(Daily Report – July 20, 2011 No. 153)

These natural stone materials (C and D armor rock) require longer lead time than locally available processed concrete materials (A and B/C armor rock), and stockpiling of this material was provided for in the OMM Plan in order to allow for a quick response if repairs were necessary that required the use of these material types. No special order of material was necessary for the maintenance event.

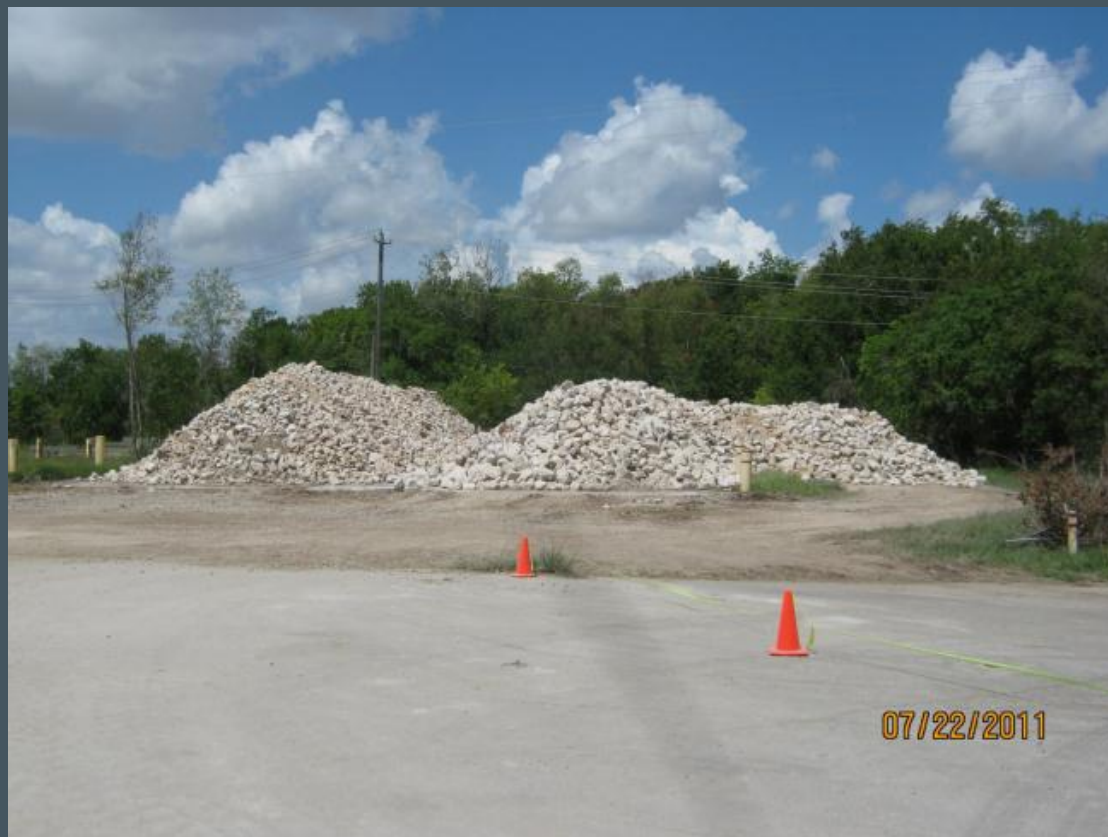
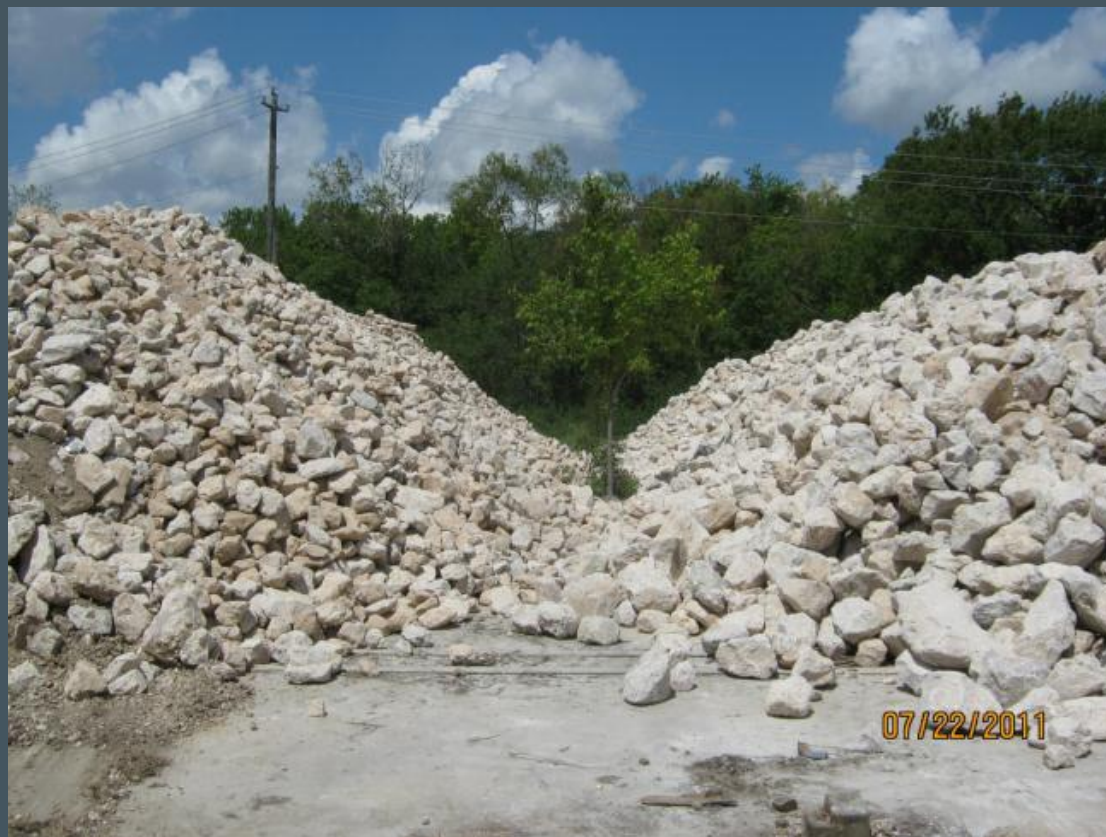
C armor rock (on left) and D armor rock (on right) stored at the off-site stockpile area. (Daily Report – July 22, 2011 No. 155)
